7 Most Common Wheel Hub Assembly Installation Mistakes

A wheel hub assembly is a critical component of a vehicle's steering and suspension system, responsible for smooth wheel rotation, alignment stability, and accurate ABS sensor feedback. Even though modern hub units are designed for durability, improper installation can lead to premature failure, comebacks, and safety concerns.

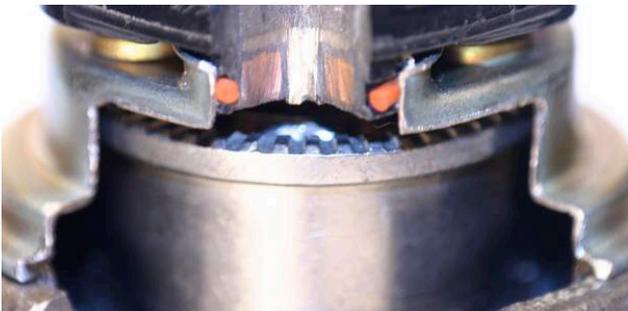
2

Contaminated or Damaged ABS Sensor

Dust, debris, or fingerprints on the encoder ring can interfere with ABS speed signals.

- Avoid touching the magnetic encoder.
- Ensure the sensor is correctly aligned and securely plugged in.

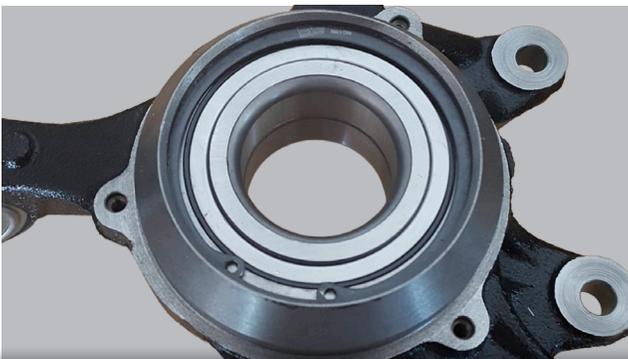
3

Installing the Hub Backwards (*Incorrect Orientation*)

Some hub assemblies appear symmetrical but are directional due to sensor placement.

- Confirm the correct orientation of ABS connectors and the backing plate before installation.

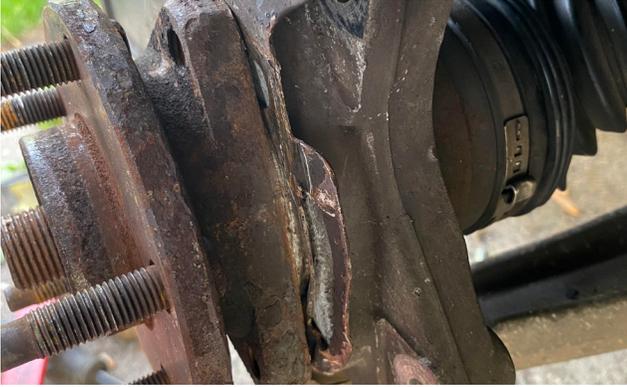
4

Damaged Mounting Surfaces

Rust, old gasket material, and burrs on the knuckle or flange prevent the hub from sitting flush, which can lead to:

- Brake pulsation
- Premature bearing wear
- Misalignment causing ABS signal errors

- Clean mounting surfaces thoroughly.
- Inspect for corrosion or damage before installing the hub.

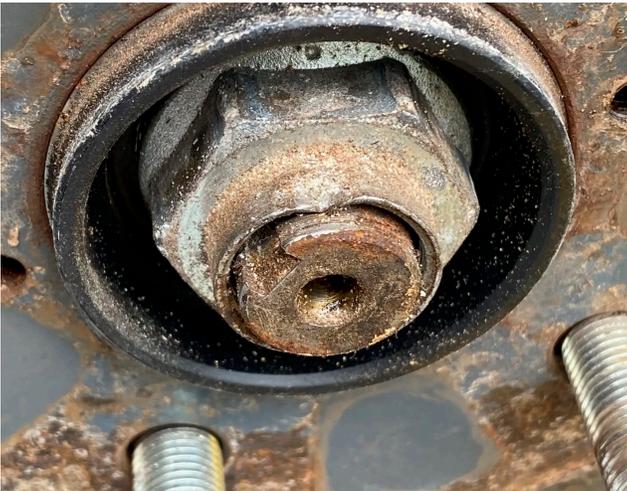
5

Reusing Old Hardware

Old bolts and axle nuts may stretch, weaken, or lose clamping force.

- Replace all single-use fasteners.
- Apply proper bolt lubrication as specified by the OE.

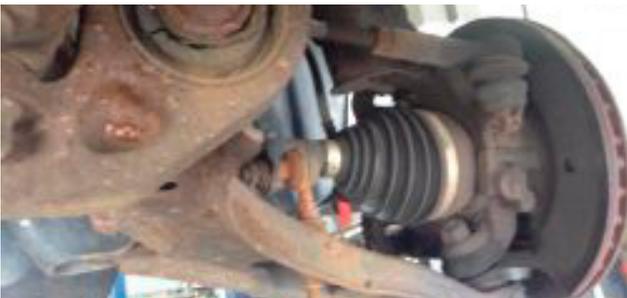
7

7. Ignoring Related Suspension & Steering Wear

A failing hub may be a symptom, not the root cause. Worn ball joints, tie rods, and bushings increase load stress on the hub.

- Inspect adjacent suspension components during hub replacement to avoid repeat failures.
