# PTC Blackhawk™ Premium Hub Assemblies

## How Blackhawk Hub Assemblies Help Overcome Common Installation Issues in the Shop

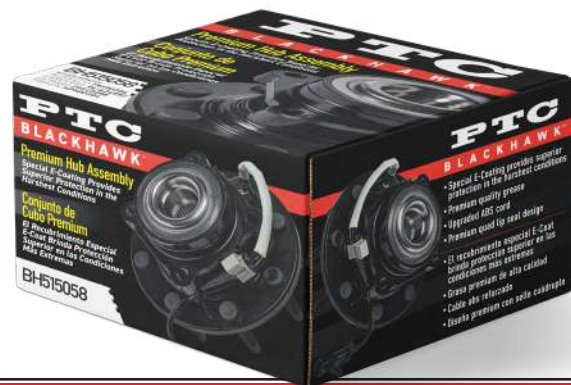
Hub assembly replacement is one of the most common undercar repairs, and one of the most frequent sources of installation headaches and comebacks. Corrosion-seized hubs, damaged ABS sensor cables, contaminated bearings, and poor fitment cost technicians time on the lift and shops money in warranty claims. PTC Blackhawk Premium Hub Assemblies are engineered with features that directly address these shop-floor problems.

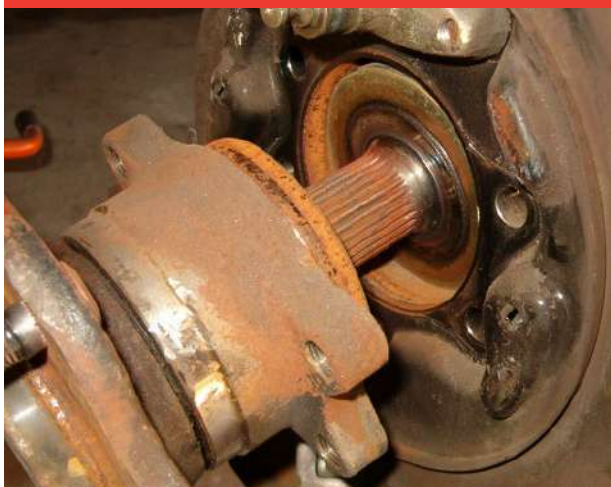
# 1

### Rust Buildup on Mating Surfaces

Standard hub assemblies corrode into the knuckle bore, making future service a battle of penetrating oil, heat, and hammers. Rust buildup on mating surfaces can also cause improper seating during installation, leading to runout, vibration, and premature bearing wear.

Special electrophoretic e-coating provides uniform, durable corrosion protection across the entire assembly while maintaining tight dimensional control on critical interfaces. The hub seats correctly in the knuckle at installation, resists rust bonding over its service life, and preserves long-term performance in demanding under-vehicle conditions, meaning the next tech to service the vehicle won't be fighting a seized unit.

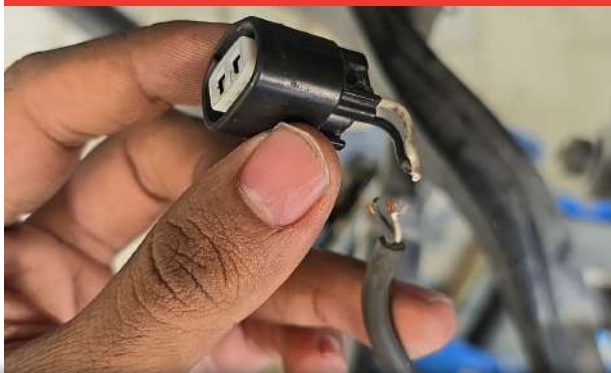
# 2

### Inadequate Waterproofing on Sensors

ABS sensor cables and connectors are a leading cause of hub-related comebacks. Connectors crack during handling or removal, and marginal sensor sealing lets moisture in, triggering intermittent ABS/traction control lights weeks after the repair.

The upgraded ABS cord features double O-rings that improve the waterproof performance of the sensor, plus an upgraded molded ABS connector designed to prevent cable breakage. Fewer damaged connectors at install, fewer moisture-related ABS codes after the vehicle leaves the bay.

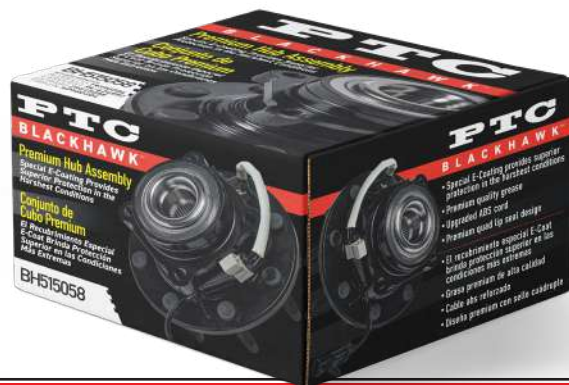
How Blackhawk Hub Assemblies Help Overcome Common Installation Issues in the Shop

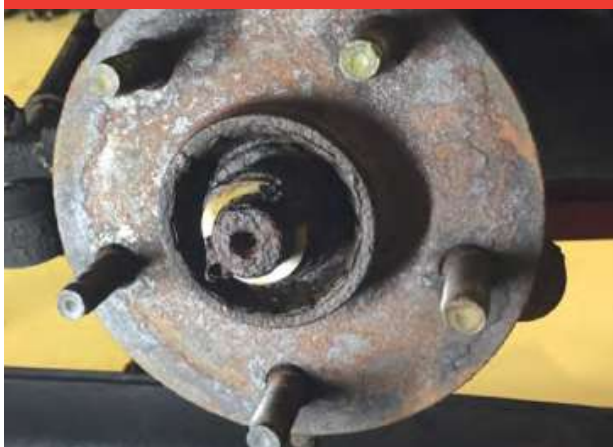
3

### Poor Seals Causing Bearing Failure

Water intrusion, road salt, and grease washout are the top killers of replacement hub bearings, especially in severe climates and on off-road vehicles. A failed seal turns a “lifetime” bearing into a 12-month comeback.

A premium quad lip seal design uses four distinct sealing lips, versus standard single- or dual-lip seals, for enhanced protection, durability, and contamination control. Benefits include extended bearing life, improved protection against water and road salt intrusion, reduced risk of grease leakage, and improved performance in severe climates and off-road conditions.

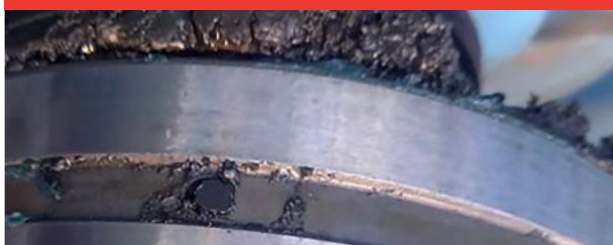
4

### Poor Quality Grease Thermal Breakdown

Bearing grease that can’t handle micro-movement (fretting), moisture, or brake heat breaks down early, causing noise complaints and repeat repairs.

Blackhawk hubs are filled with premium quality grease engineered for fretting resistance, rust prevention, and heat resistance - protecting the bearing through real-world duty cycles.
